Suction Safety

How ANSI/APSP-7 Prevents Tragedy

BY STEVE R. BARNES

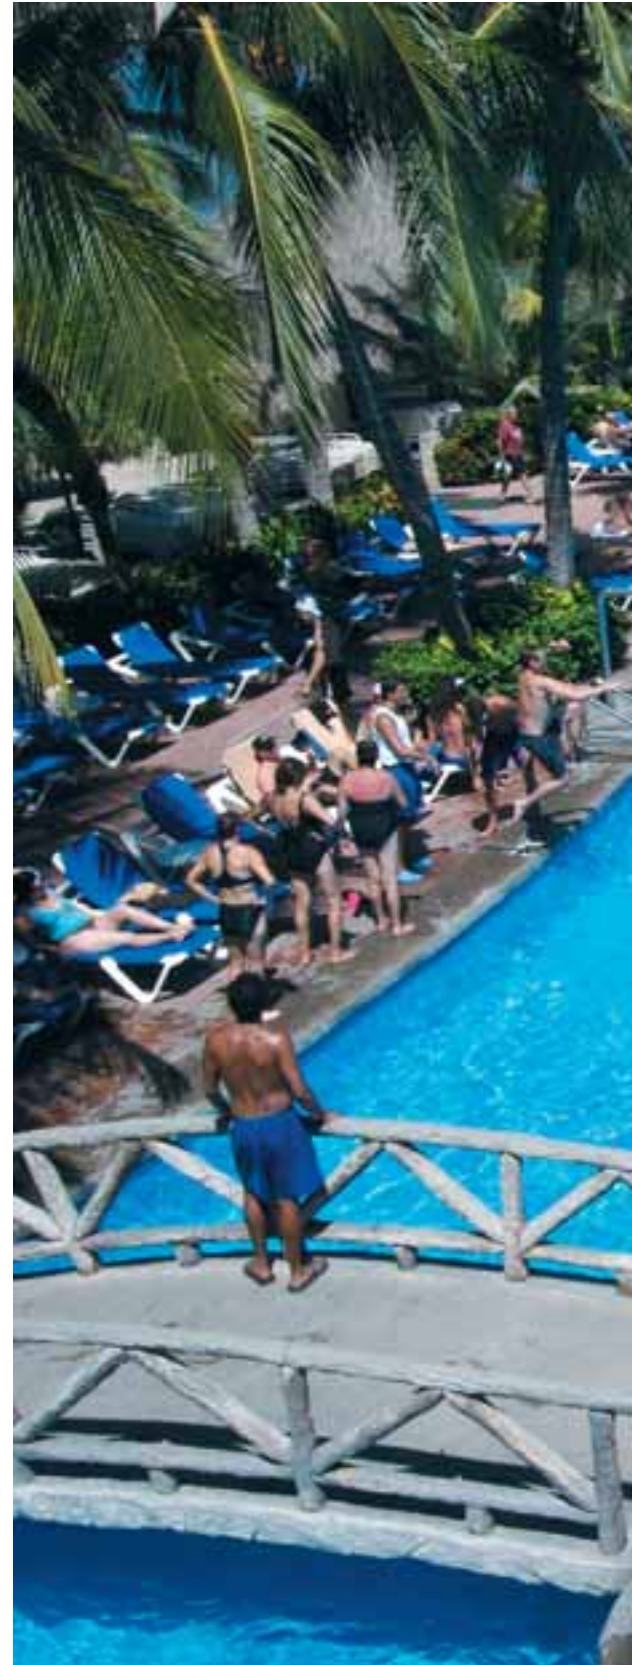
This pool is constructed without submerged suction outlets, i.e., no main drains. One hundred percent of the water feeding the filtration system comes through the skimmers located around the perimeter. Circulation is provided by returns spaced every 15 feet around the perimeter.
